Wood Design
FOCUS

In This Issue:
Wood Research in Disasters

A Tale of Two Houses: Investigation of Disproportionate Damage in 2011 Tuscaloosa, AL Tornado

A Tale of Two Houses: Investigation of Disproportionate Damage in the 2011 Tuscaloosa, AL Tornado

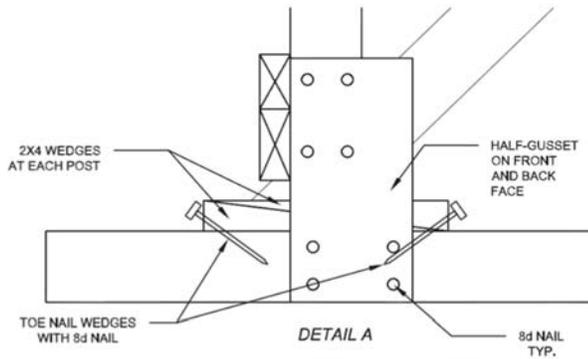
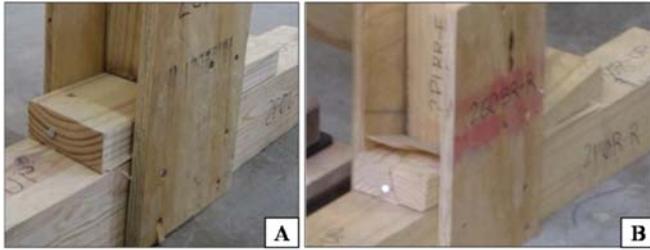
danger ensues. Figure 3 is a sketch showing a 4x4 post bearing on two wedges, which, in turn, bear on a 4x4 sole plate that is in contact with the surface of a damaged structure. The two photos in the figure show the support before and after the cupping of the wedges, the visual sign of distress for rescue workers. Also, the audible sounds of splitting of the soles and other wood members provide warning of distress.

Figure 3. Detail of Fuse Built Into Shoring. (A) Fuse Before Activation, (B) Fuse After Activation.

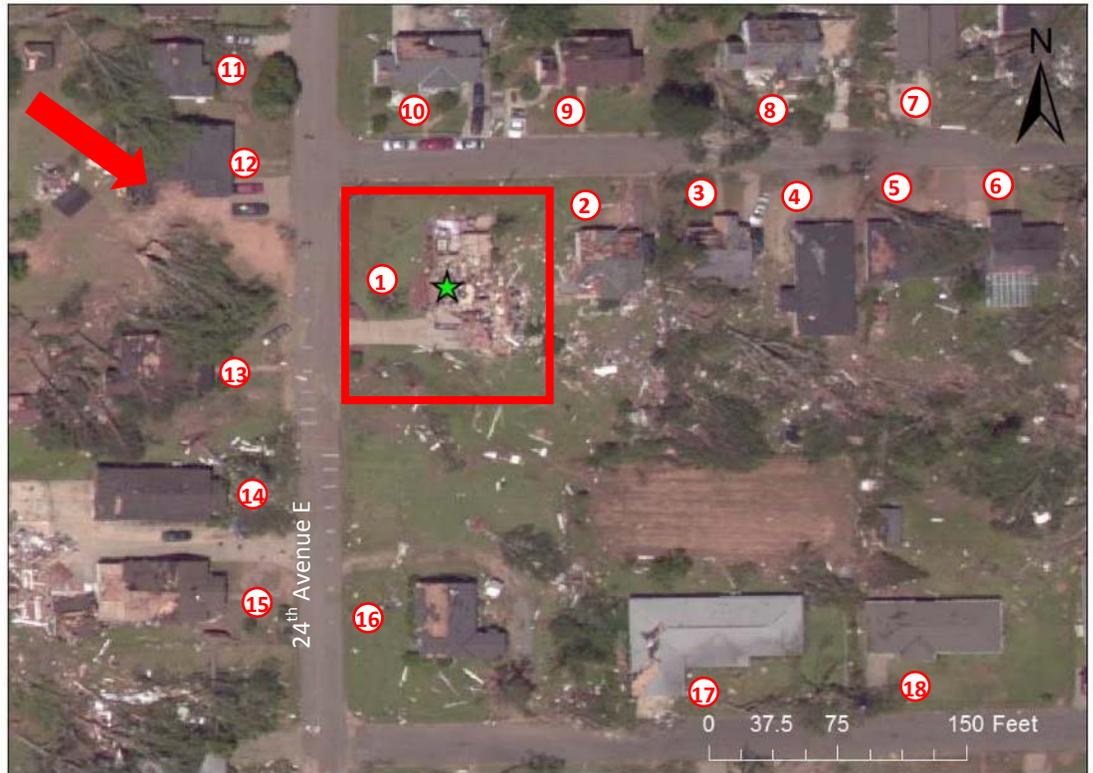
An aerial view of the damage, provided in Figure 3, demonstrates the heavy damage sustained by this home (Home #1), in contrast to the much lighter damage sustained by the surrounding homes.

Figure 3. Aerial View of Damage to WR-521 and Surrounding Homes. (The Red Rectangle Outlines the Location of WR-521 and the Red Arrow Depicts the Approximate Wind Direction Based Upon the Debris Streak from the House and Direction of Tree Fall Near the Building.)

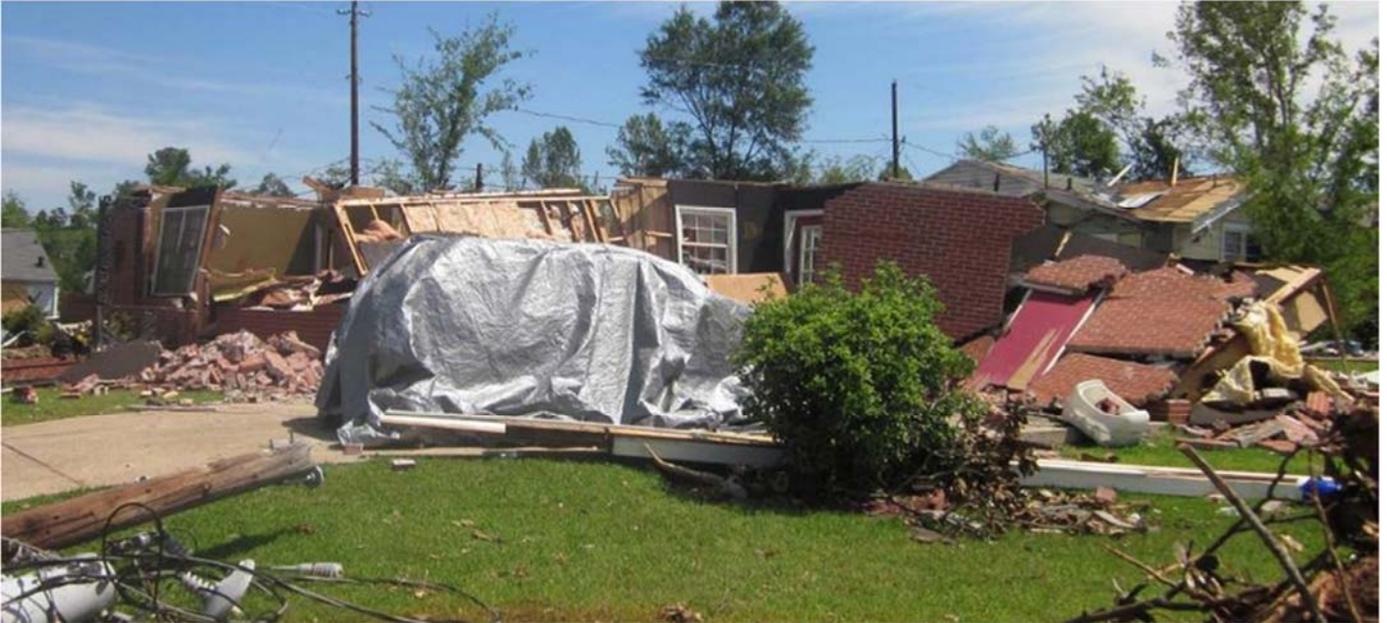
The primary damage to the case study structure consisted of complete roof removal and collapse of exterior walls. The survey team tried but could not locate any debris for the roof structure (rafters, wood sheathing) and none was observed using aerial imagery. Ten roof joists did remain attached to the walls along the far side of the house opposite the carport.

Exterior walls along the front (facing west) and the sides also collapsed, and most interior walls remained standing (Figures 4 and 5). The observed damage most closely corresponded to DOD 7 (“Exterior walls collapsed”) for FR12 in the EF-Scale, which has an expected wind speed of 132 mph and thus an EF2 rating.

Figure 4. View of the Front of the House Showing the Roof Missing and Some Exterior Walls Collapsed.

The lack of major structural damage to the surrounding homes, most of which were constructed around the same time suggests that catastrophic failure could have been prevented. A more robust structural design that included connections in the vertical load path designed to resist the wind loading on the overhangs could prevent initiation of failure. The use of metal straps rather than toe-nails at the rafter to wall connections were needed to prevent the failure (complete removal) of the roof. Finally, a study the University of Western

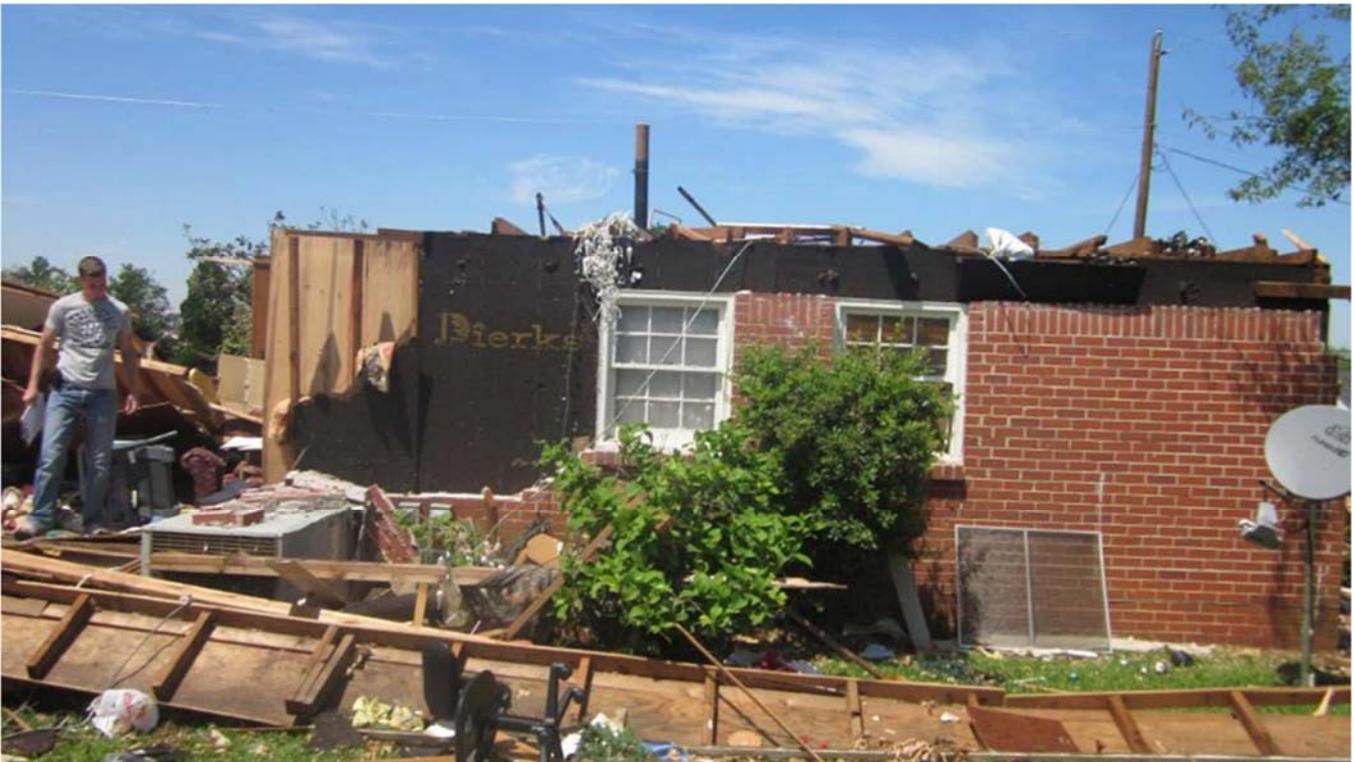
Figure 5. View from Rear of the House showing the Fiberboard Sheathing and Rafter Spacing. The Soffit Along the Back of the House is Shown in the Foreground.

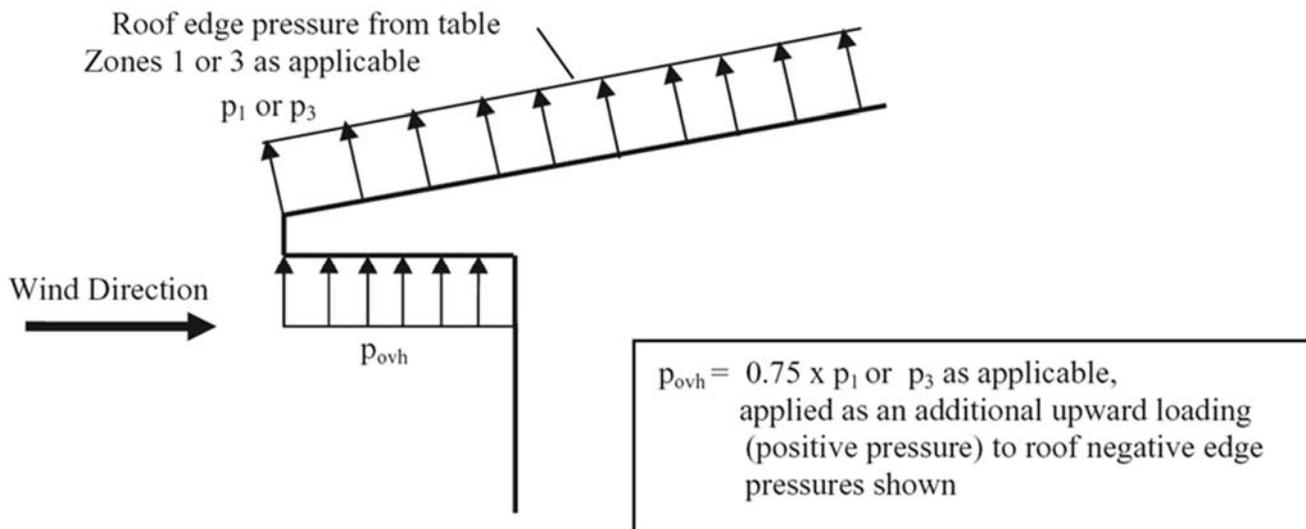
Figure 6. Roof Overhang Pressures Along a Windward Wall as Given in ASCE 7-10 Figure 27.6-3. p_1 and p_3 Refer to the Edge and Corner Roof Pressures, Respectively.

The entire section of roof over the open carport was supported two walls and a single column at the corner. The wind flow to these areas of the home created uplift forces on the large overhangs. According to the Main Wind Force Resisting System (MWFRS) provisions of ASCE 7-10 (ASCE, 2010), the underside of overhangs experience 75% of the magnitude of the roof edge pressures, in addition to any negative pressure on the roof itself (Figure 6.) This combined load increase was the critical factor in the premature failure of this roof.

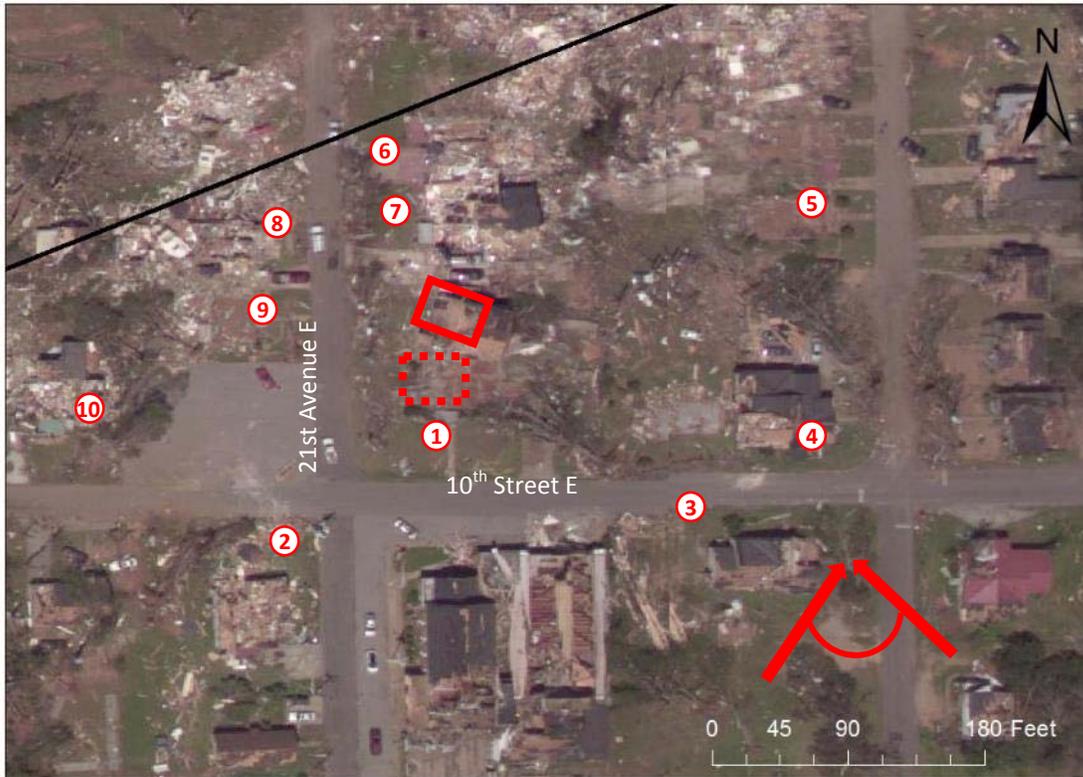
The area surrounding the home is shown in Figure 8 and the age and damage to the surrounding homes is given in Table 3. Some homes just north and northeast of this home, closer to the tornado path, suffered complete destruction with only foundation remaining. Just south of the home, across 10th St. East, a church suffered major damage with large portions of the roof destroyed. Some of the debris from the church was noticeable in the yard of the case study home. None of the surrounding homes were observed to have shifted off of their foundation intact, although several homes closer to the tornado

Figure 8. Aerial View of the Damage to the Case Study #2 Home and Surrounding Area. The Dotted Red Rectangle Highlights the Original Location of the Home. The Solid Red Rectangle Shows the Final Resting Place of the Home. The Solid Black Line Indicates the Estimated Tornado Centerline. Numbered Labels Refer to Table 3. The Red Arrows Show the Range of Wind Directions During the Passage of the Tornado.

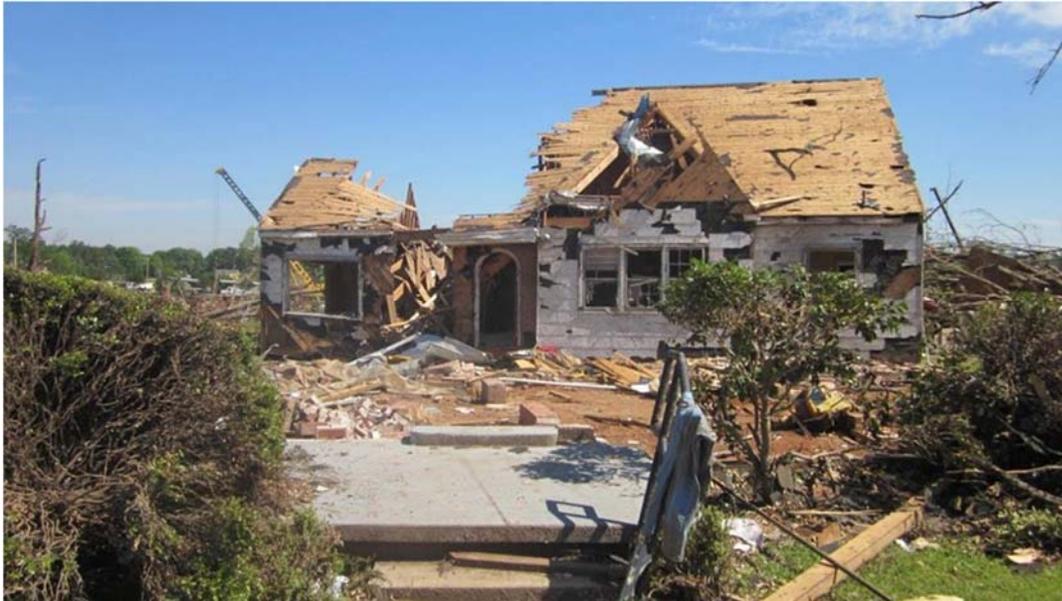
The damage to the house (shown in Figures 9, 10 and 11) was remarkable, in that the main structure remained intact, but the entire structure was shifted approximately 40 feet off of its foundation. The building was shifted due

north towards the center of the tornado path. The majority of the structural damage appears to have been caused by the collapse of the upper portion of a large brick chimney at the front of the house, which fell, damaging a large portion of the roof structure. A gable wall on the south side of the roof also failed and was removed entirely. However, much of the wood siding remained intact, and most of the wood planks both on the roof and walls remained in place. Over 90% of the asphalt roof shingles and underlayment were removed

Figure 9: Front View of the House (Looking North). The Front Door Used to be Even with Back Edge of the Concrete Slab Seen in the Foreground of the Photo. The Chimney was Located Just to the Left of the Front Door.

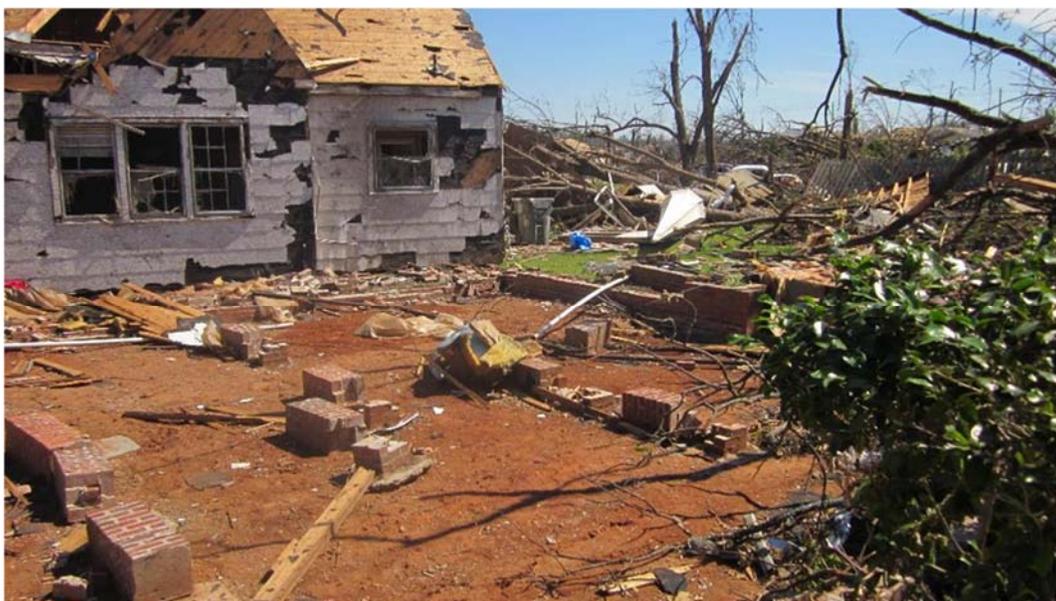
The lack of any positive wall-to-foundation anchorage to the home, combined with the additional robustness provided by the diagonal wood plank walls and wood plank roof, gives a likely explanation for the final damage state that was observed. The interior framing of the live-in attic appears to have been fastened to the rafters, providing additional resistance against the uplift forces. The diagonal wood plank sheathing was

Figure 10. The Brick Piers Used to Support the Interior Portions of the House. No Positive Connections Existed Along the Load Path of the Foundation to Resist Uplift.

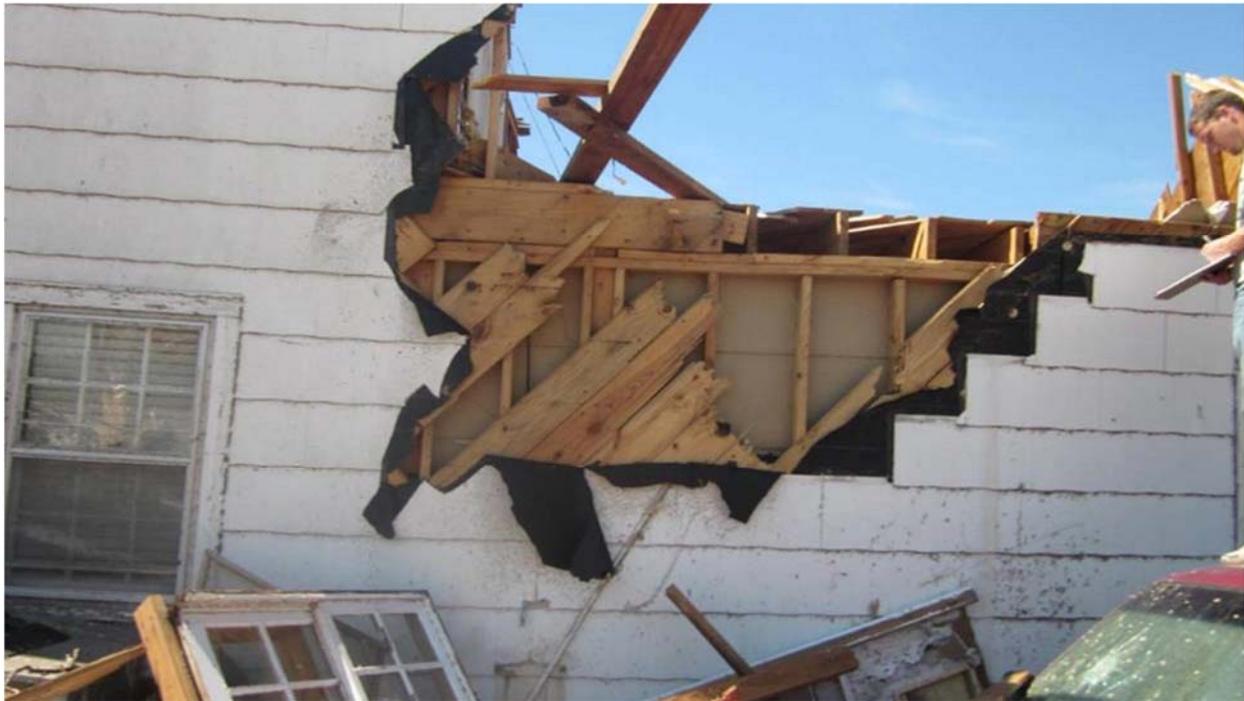
Figure 11. View of the Back of the Case Study #2 House (Looking South), Showing the Diagonal Sheathing, Wall Framing and Wood Siding.
