*Wood Design*  
**FOCUS**

**Volume 26, Number 2**

**Inspection of Existing Decks**

# Common Deck Construction Issues From an Inspector's Point of View

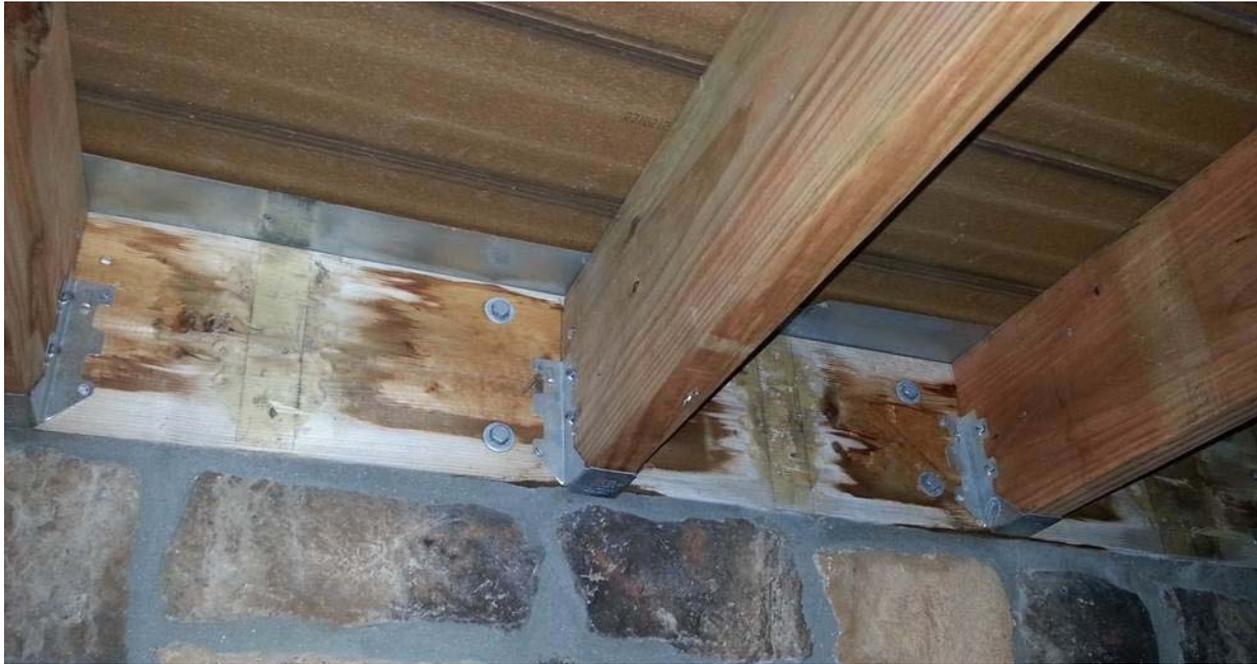
No matter how many lag screw heads can be seen on the face of the ledger or installed, these fasteners have little function if connected to a rotten band joist. If ledger decay is so severe that it is visible on the exposed face, then there is no repair or rehab to be done, a complete replacement may be necessary.

**Figure 1. Ledger Plate Showing Water Staining**

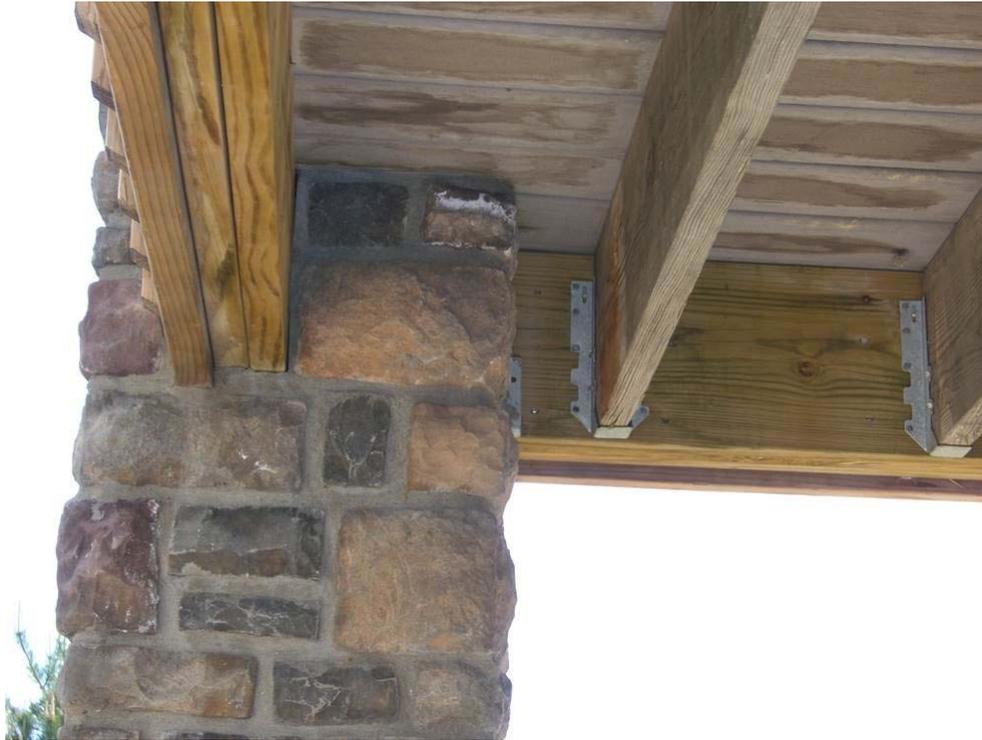
**Figure 2. Intersection of Deck Framing With Wrapped Column. Proper Detailing of Moisture Removal Is Needed To Prevent Moisture Accumulation Within Framing**

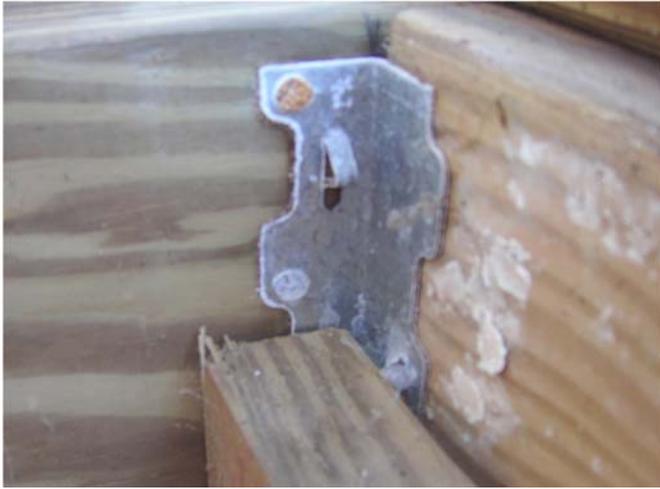
**Figure 1. Corrosion of Metal Deck Fastener**

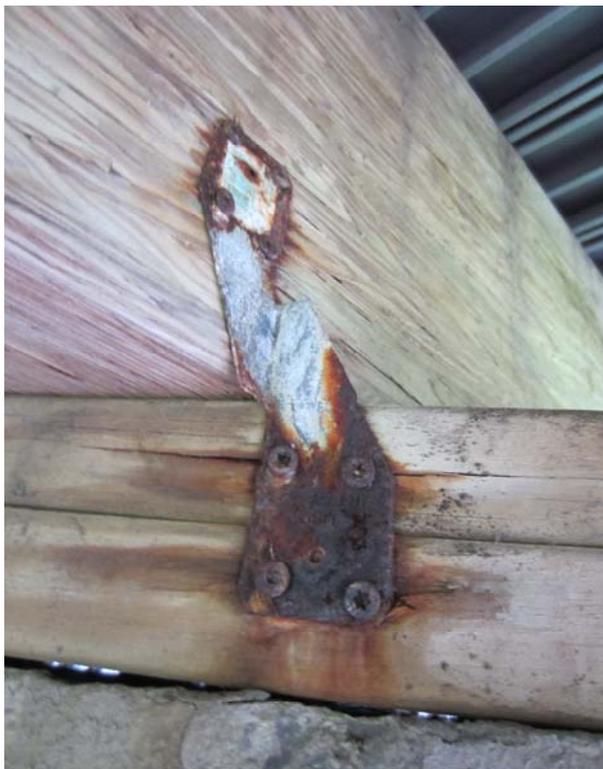
**Figure 2. Corrosion of Hold-Down And Fastener. Improper Fastener Use**

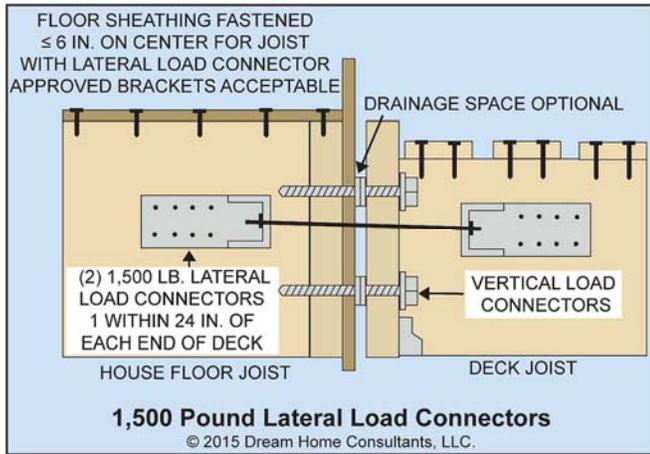
**Figure 3. Deck Ledger Connection with Floor Joists Parallel to Deck Joists Using Threaded Rod**

As previously mentioned, lateral load specifications are less clear. Lateral connectors which appear to have been required for the past several code iterations are rarely installed. These threaded rod-type connectors are difficult to install even under ideal conditions. Figure 3 shows a typical detail. Note the requirement for extra fasteners in the floor sheathing. Installing threaded rod-type lateral load connectors under less than ideal conditions, especially in retrofit situations, has the potential to be very difficult and expensive. The 2015 IRC (ICC 2014a) provides a prescriptive solution to the lateral load connector issue. Instead of a difficult to install threaded rod-type connector, a connector that screws into a wall plate can be used, such as a Simpson StrongTie DTT1 (Figure 4). Alternatively, the deck can be built as a free-standing structure.

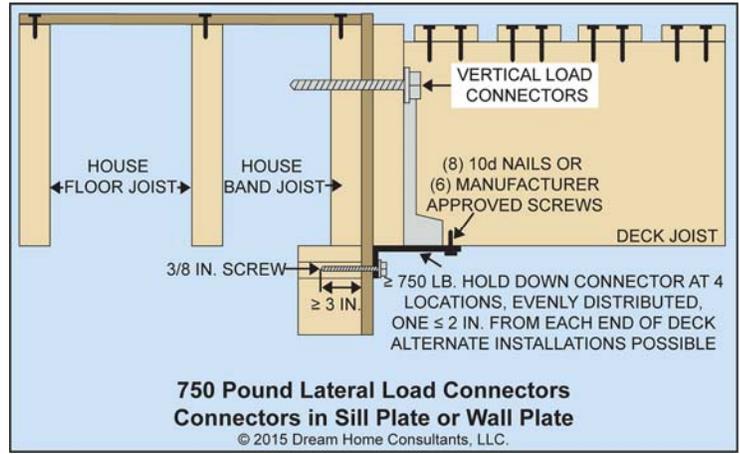
**Figure 4. Deck Ledger Connection with Floor Joists Perpendicular to Deck Joists**

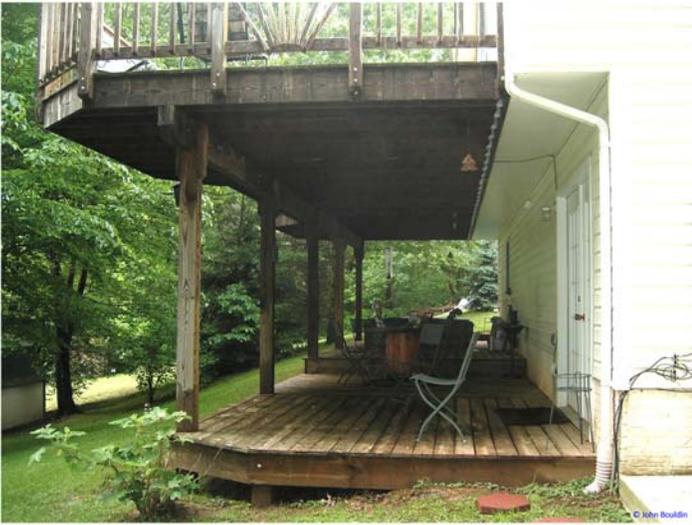
**Figure 5. Example of Deck Ledger Attachment to House Cantilever**

commonly observed in the field (Figures 5 to 7), DCA 6 prohibits these connections, and section R507.2 of the IRC implies that such connections can only be made to band joists that rest directly on a sill plate or wall plate. Ledger attachments to a non-supported band joist are therefore subject to shear failure at the connection between the band joist and the ends of the house floor joists. A potential mode of failure for a cantilever connection is illustrated in Figure 8, where the ledger remains solidly bolted to the band joist, but the band joist separates from the house joist ends.

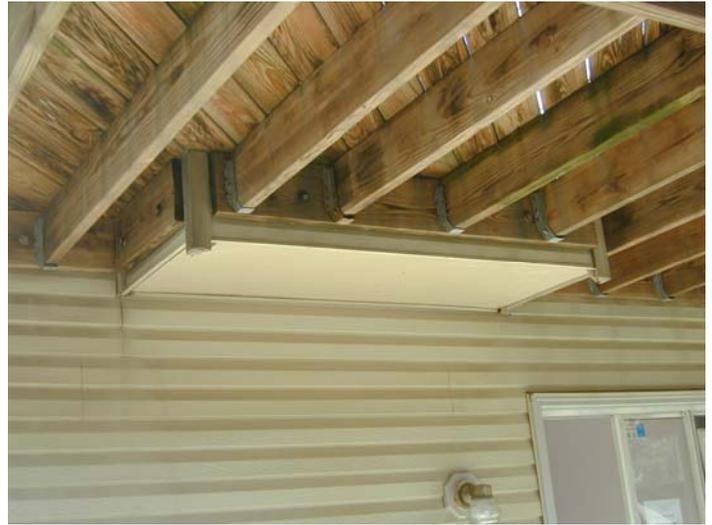
**Figure 6. Example of Deck Ledger Attachment to House Bump-Out Cantilever**

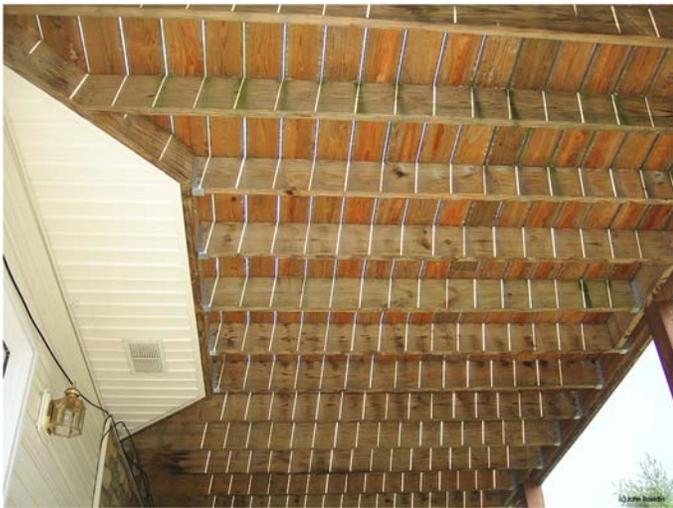
**Figure 7. Deck Ledger Attachment to House Bay Window Cantilever**

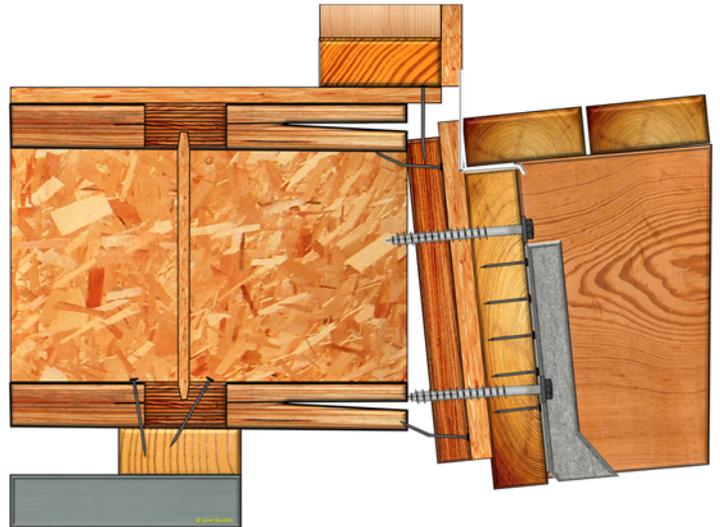
**Figure 8. Band Joist Separation From House When Band Joist Is Unsupported by a Sill Plate or Other Bearing Member**

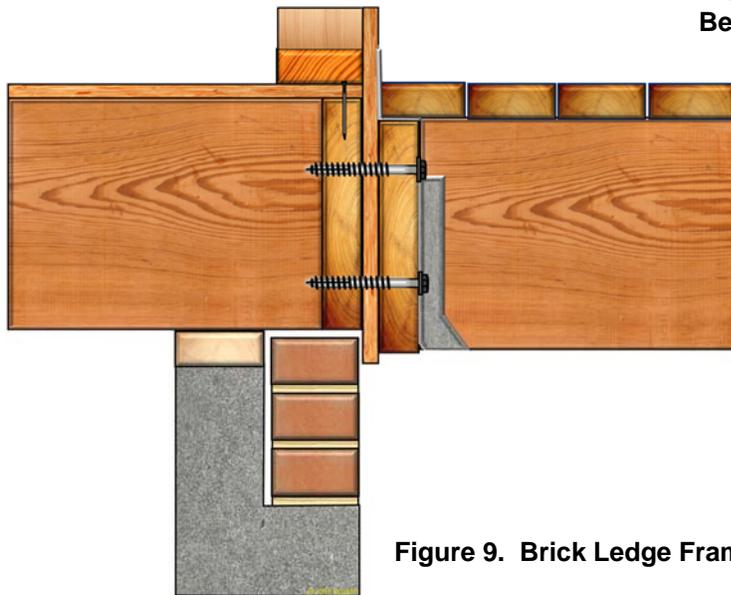
**Figure 9. Brick Ledge Framing Cantilever**

Cantilever connections are usually easy to identify but can be less obvious when the cantilever involves a short projection over an exterior brick or other veneer as illustrated in Figure 9. In such cases, from an exterior view of the structure, the deck-to-house connection may appear to be correct because there is no discernable cantilevered projection. Unless the interior floor framing structure is visible, the concealed cantilever arrangement makes it difficult to determine. The American Wood Council recently provided the following clarification on brick ledge cantilevers:

*Any cantilever of the house floor structure over a bearing wall in which the house band joist or rim joist does not have full bearing support would qualify as a cantilever per DCA 6. In*

*such cases, a non-ledger deck or engineering evaluation would be required. (AWC 2016).*

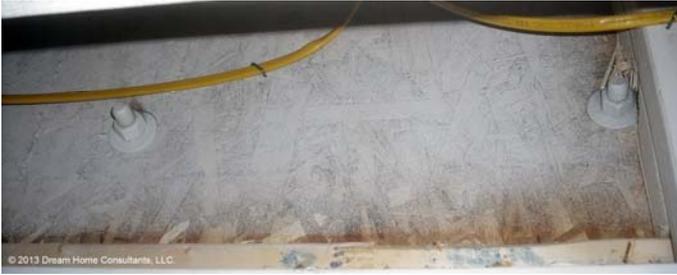
**Figure 10. Bearing Deck Ledger Improperly Bolted To the Web of a Wood Composite I-joist**

Examples of non-compliant ledger attachments abound in practice. Figure 10 shows a ledger improperly attached to an I-joist rim board. Figures 11 and 12 show a ledger attached only to exterior sheathing. Figure 13 is a photograph of a ledger connected to the ribbon boards of an open web floor truss system. Figure 14 depicts an improper ledger lag screw placement with respect to the interior band joist. Figure 15 shows an improper ledger connection through an exterior man-made stone veneer. Some older decks were attached to the house using only nails. It is still quite common to find these decks during a home inspection (Figure 16). Figure 17 is a photograph on another non-conforming connection; that of a perpendicular beam (carrying floor joists) to the ledger board. IRC section R507.2 specifically prohibits this connection, though it is still found in field inspections.

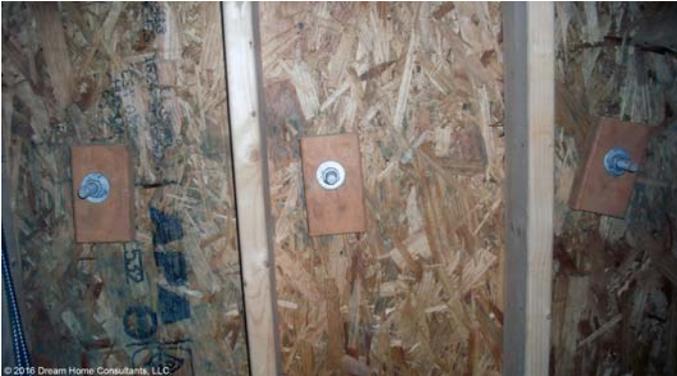
**Figure 11. Bearing Deck Ledger Improperly Bolted to Exterior OSB Sheathing With No Additional Support**

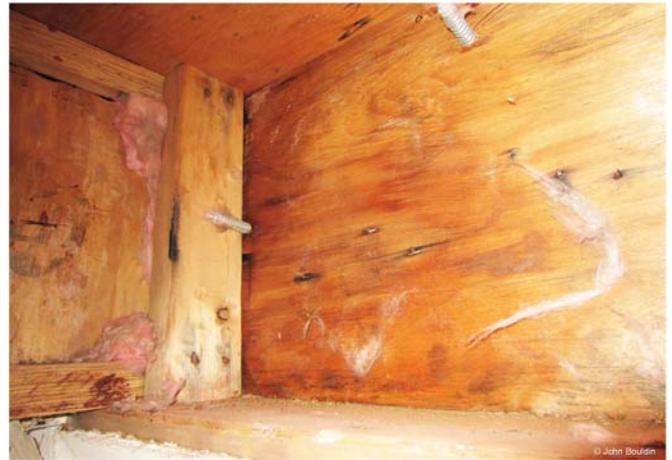
**Figure 12. Bearing Deck Ledger Improperly Attached to Plywood Sheathing**

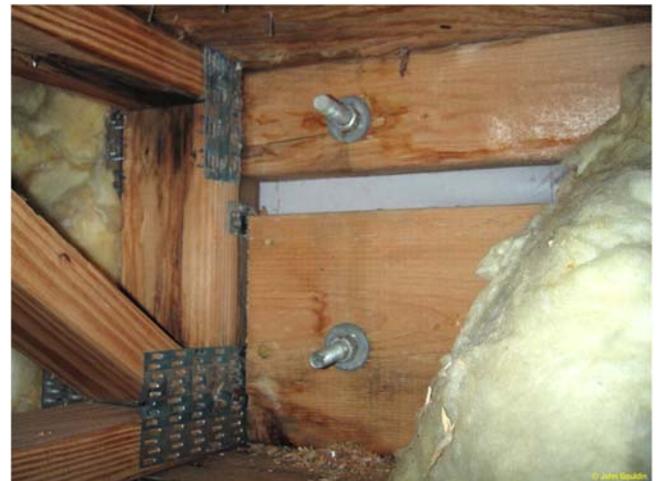
**Figure 13. Bearing Deck Ledger Improperly Attached to Ribbon Board and Spacer Block in Open Web Floor Truss Assembly**

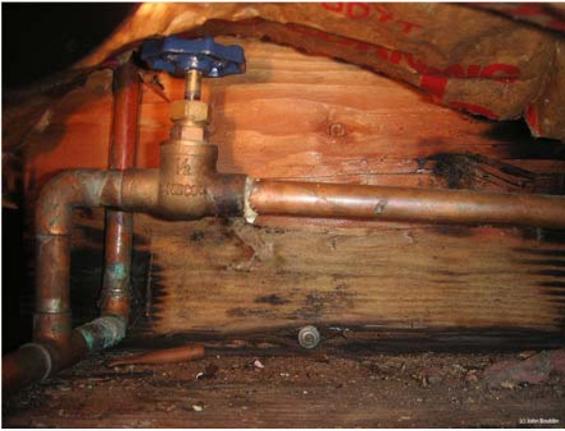
**Figure 14. Lag Screw Improperly Securing Deck Ledger Without Proper Edge Distance From House Band Joist. Note Corrosion At Lag Screw.**

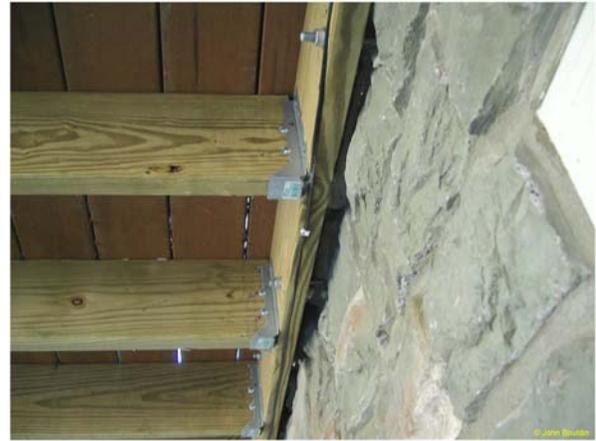
**Figure 15. Bearing Deck Ledger Improperly Attached Through Adhered Masonry Veneer**

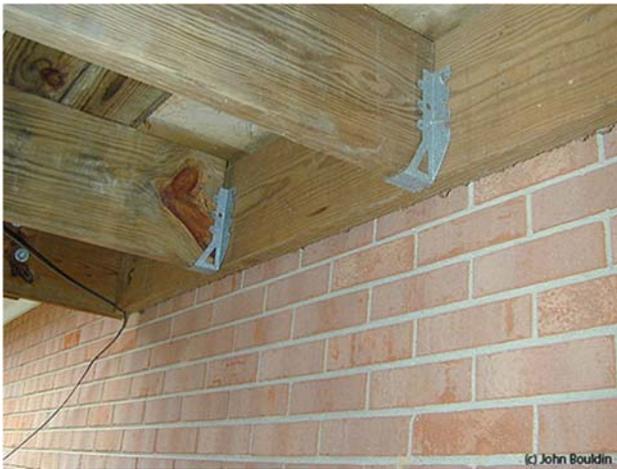
**Figure 16. Bearing Deck Ledger Improperly Attached to Brick Veneer Using Nails**

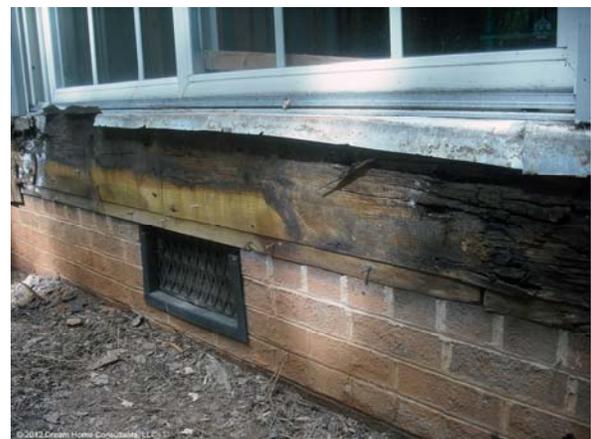
**Figure 18. Structural Deterioration of Wood Behind Band Joist. No Ledger Flashing Present.**

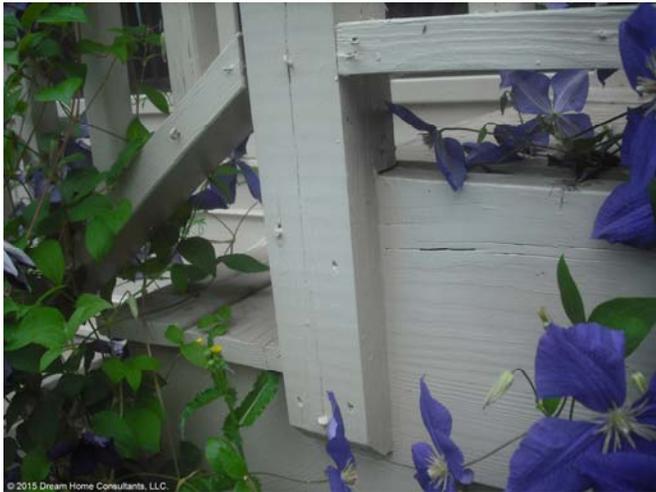
**Figure 20. Notched Guard Posts Only Attached With Nails Are Non-Compliant**

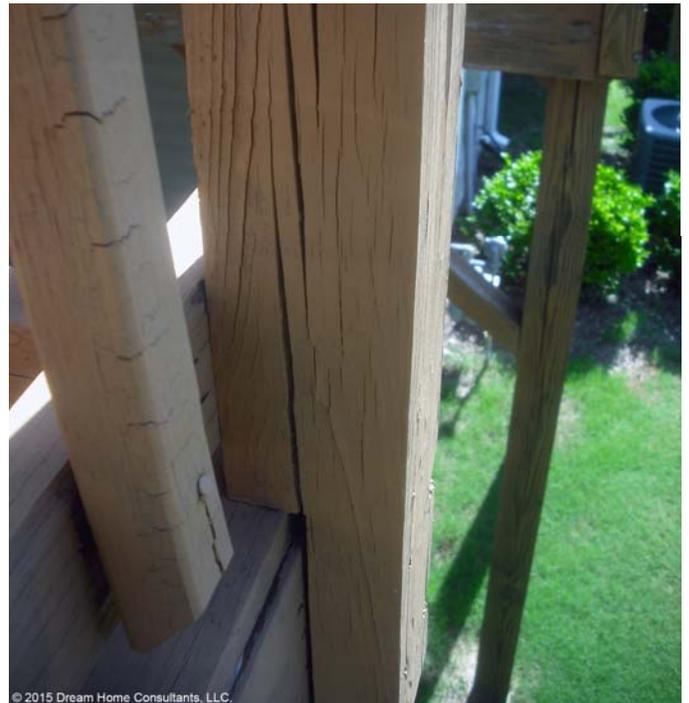
**Figure 21. Notched Guard Posts Only Attached With Nails Are Non-Compliant. Note Splitting of Post At**

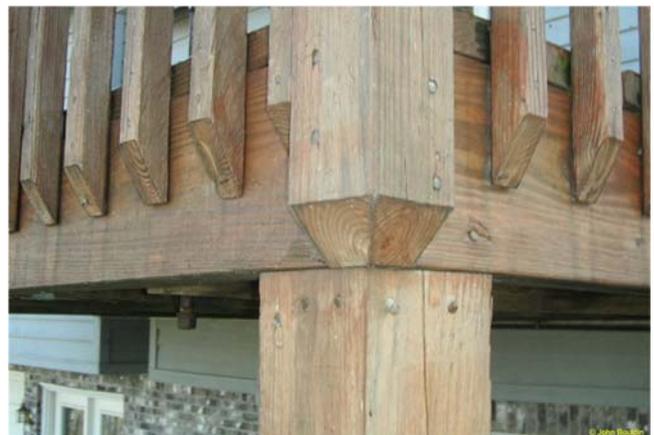
**Figure 22. Notched Guard Posts In Two Directions and Only Secured With Nails Are Non-Compliant**

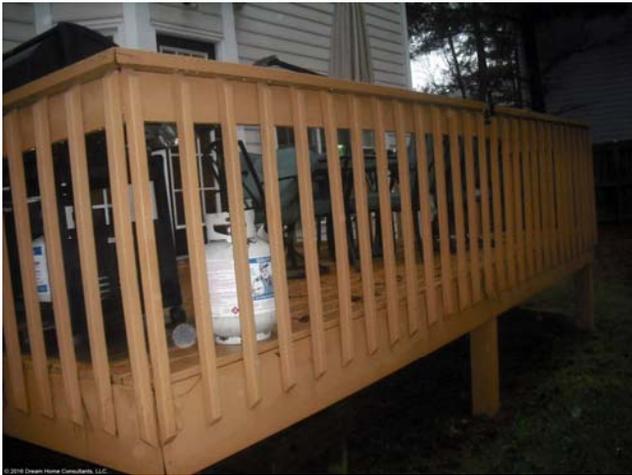
Figure 23. Missing Guard Posts in Railing

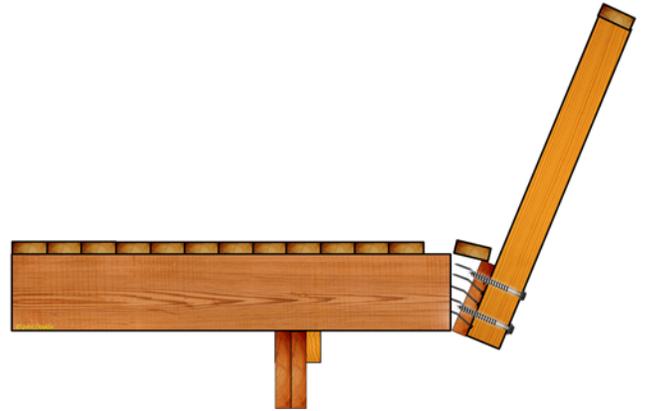
Figure 24. Failure Mode for Guard Posts Connected To Band Joist, Where Band Joist Peels Away from Deck Joists

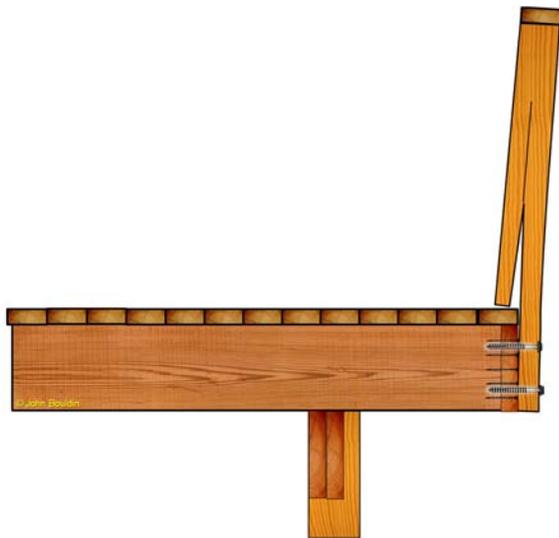
Figure 25. Failure Mode for Notched Guard Post Where Post Splits Vertically

from the end grain of the deck joists, and Figure 25 depicts a potential failure mode for notched guard posts.

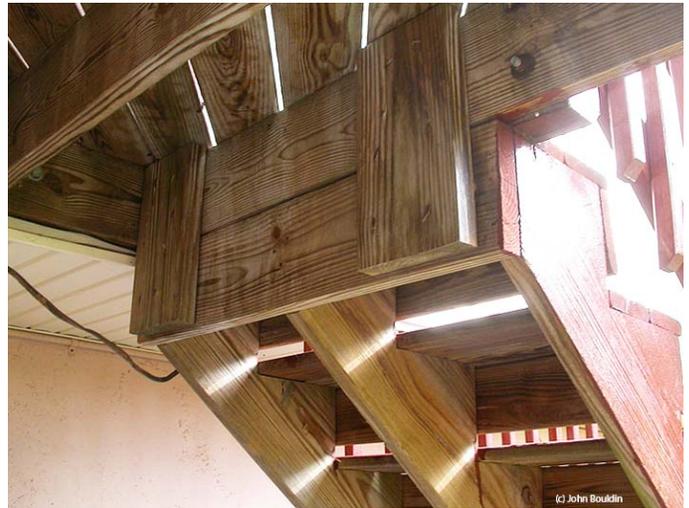
Figure 26. Dropped Header Held By Nail Cleats Supporting Stair Stringers. Cleat Nails are Loaded in

Stairways are inherently dangerous even when built properly, and IRC requirements such as guardrail heights, stair step height and consistency requirements, and handrail configurations are the same for exterior stairs as for interior stairs. Deck stair defects are common, and include uneven riser heights and uneven tread depths, handrails that are not graspable, and lack of a solid landing at the bottom of stairs. Deck stair installation defects most likely to cause stair failure include stringers attached to drop headers attached by nails (Figure 26), and stringers with insufficient throat depth (Figure 27).

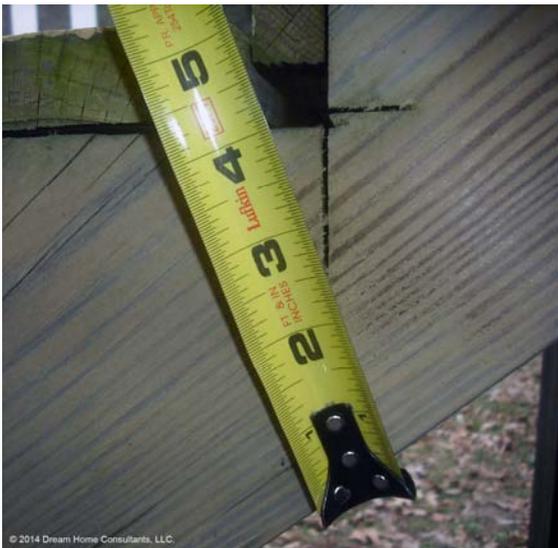
Figure 27. Shallow Throat Depth At Stringer Cuts

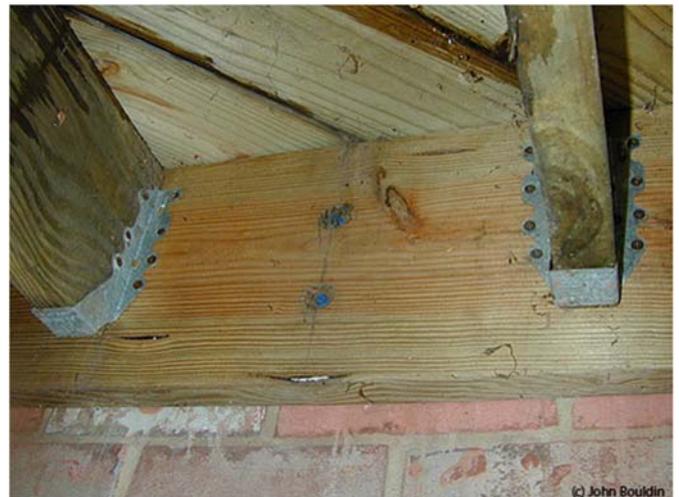
Figure 28. Recessed Ledger Screws Reduce the Effective Thickness of Ledger and Are Non-Compliant. Also, Note Improper Attachment to Brick

Some of the most common connector installation problems include the use of drywall or wood screws with hanger hardware (Figure 28), use of the wrong size or types of nails (in this case roofing nails) (Figure 29), using too few fasteners for the connections (Figure 30), and modifying the connectors (Figure 31).

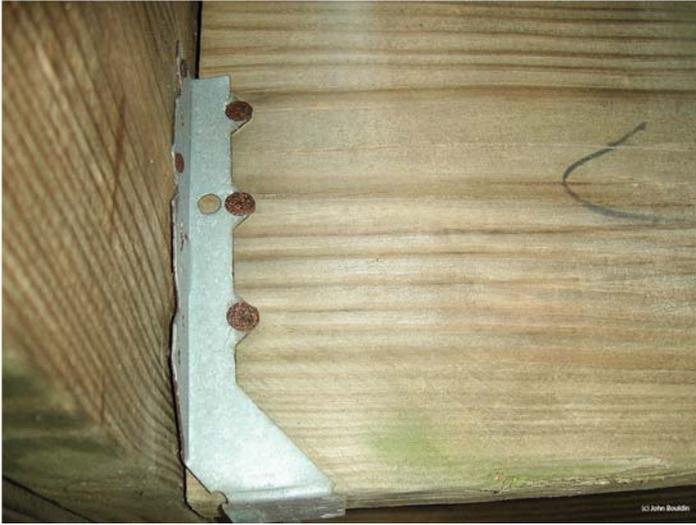
**Figure 29. Rusting Roofing Nails (Improper Fasteners) Connecting Hanger Hardware**

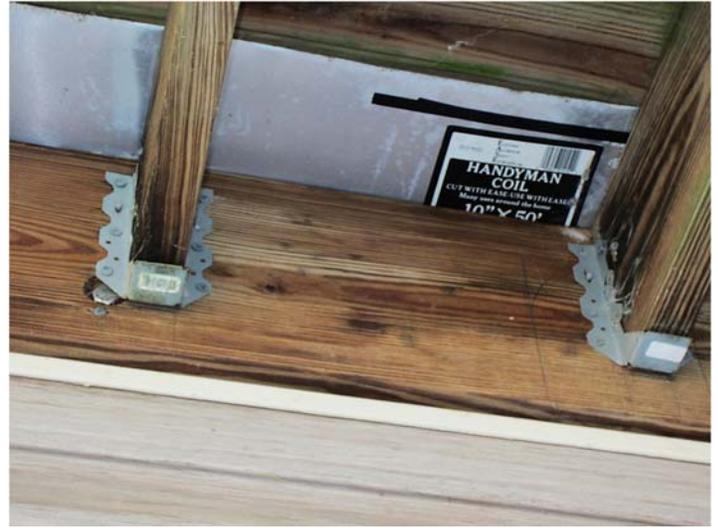
**Figure 30. Missing Fasteners in Designated Holes Within Hanger Hardware. Note Recessed Bolt in Ledger is Non-Compliant.**

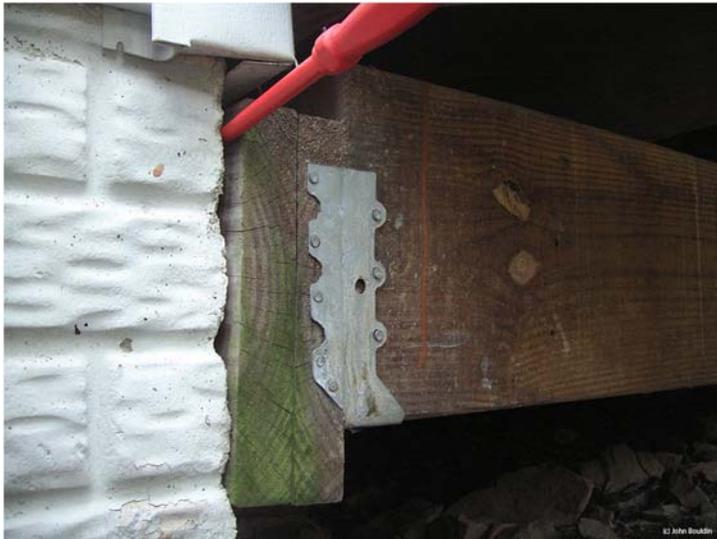
**Figure 31. Bent Flanges of Hanger Hardware Are Non-Compliant.**
