Wood Design
FOCUS

In This Issue:
Wood Research in Disasters

A Tale of Two Houses: Investigation of Disproportionate Damage in 2011 Tuscaloosa, AL Tornado

A Tale of Two Houses: Investigation of Disproportionate Damage in the 2011 Tuscaloosa, AL Tornado

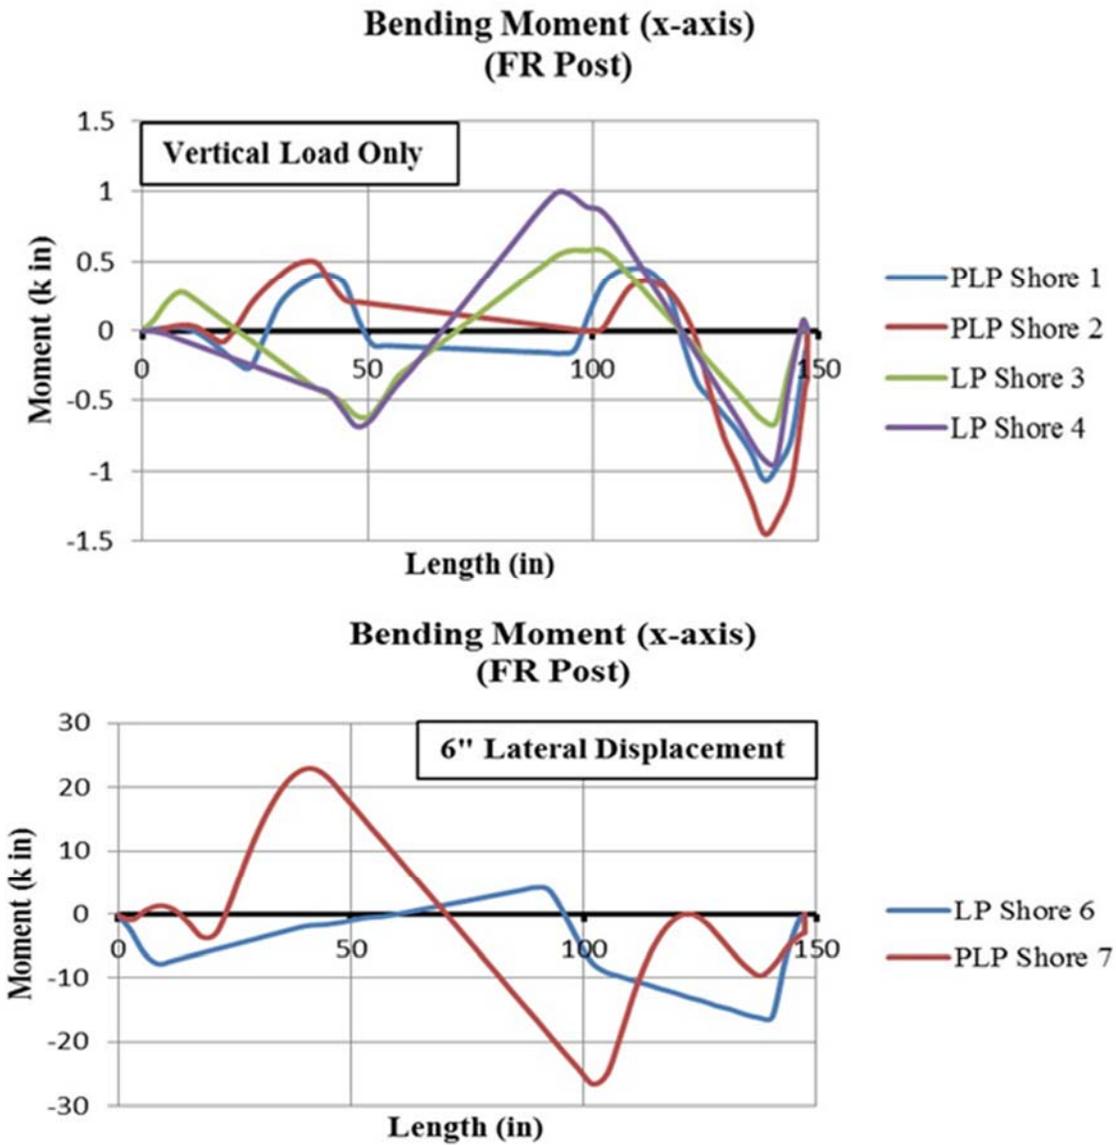
is one of the most functional tools for a design discussion for the posts, in which all ultimate failures occurred in the tests. Figure 4 illustrates a representative sample of moment diagrams, with the top half of the figure being moment diagrams for the front right post of Shores 1-4, which were loaded with vertical load only; the bottom half of that figure illustrates representative moment diagrams for the front right post of Shores 6 and 7, which were subjected to both vertical load and a lateral displacement of 6 in. The bottom of the post is at the origin of the curves. Where there is lateral displacement combined with the vertical force in the PLP shores, the restraint provided by the plywood at the ends of the middle section results in a characteristic reverse curvature of a typical rigid frame structure

- PLP shores have a slightly more compromised vertical stiffness than the LP shores primarily because of the large unbraced length in the middle story.
- For shores subjected to vertical load only, the maximum moments were higher in the PLP shores; this occurred in the top story. Below the top story,

Figure 4. Moment Diagrams Of the Front Right Posts In Shoring Exposed to Vertical, and Vertical and Lateral Loads, Respectively

the LP shores had higher moment trends than the PLP shores.

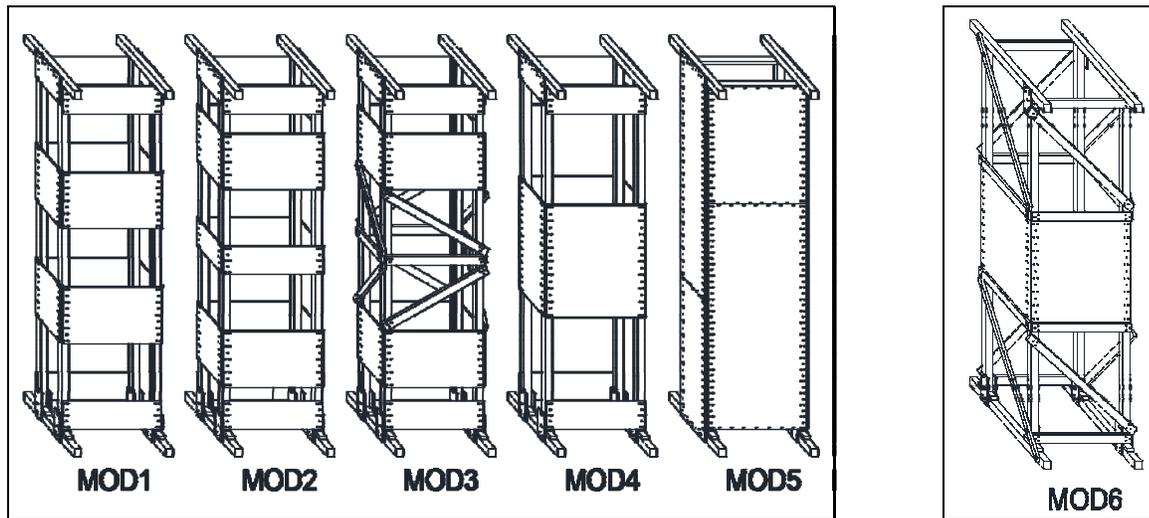
Figure 5. Modified PLP and LP Shoring, Respectively, Based on University Texas at Austin Testing and Modeling

The PLP shore has certain advantages over the LP shore and the reason is the impact of the sheathing and its multiple nailed connections on the behavior of the PLP shore. Nevertheless, both LP and PLP shores have their respective load-carrying capabilities in major part because the nails in each have the ability to absorb strain energy internally to resist work done externally. As in many light-frame structures, the sheathing and connectors often compensate for any sins of omission and commission in the design. Based on the FEM outcomes and the laboratory observations, improvements in shore design should involve

investigating more judicious placements of plywood to the posts of PLP shores in order to minimize unsupported lengths in them. As well, plywood should be considered in the LP shores.

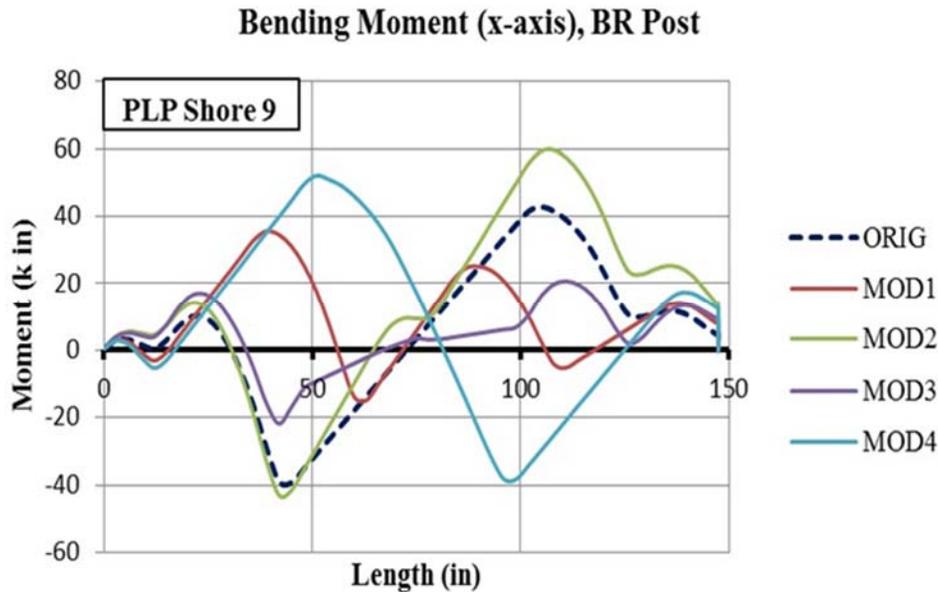
Figure 6. Moment Diagrams For Selected PLP Shoring Modifications Compared to FEMA PLP Shoring

Sparing the reader of volumes of moment diagrams, we will provide only Figure 6, which illustrates moment diagrams for one post of Shore 9 and how the moments in the original configuration—the dashed line—compare with the five modifications for PLP shores. Data such as these for each post of each shore were essential in determining the most effective modification for reducing moments.

For the PLP shores, Modification 3 had the largest impact on decreasing the bending moments in the posts of shores loaded vertically or both vertically and horizontally. Nail slips also were minimal. Modification 4 was the least helpful in reducing bending moments in the posts of PLP shores. While Modification 5 seems to be an intuitively good solution, if the plywood sheets touch then this causes the nails reach their withdrawal capacity faster. Possible mitigation of this is to maintain a gap between plywood sheets. For the LP shores, Modification 6 provided no benefit in moment reduction or nail slip reduction.

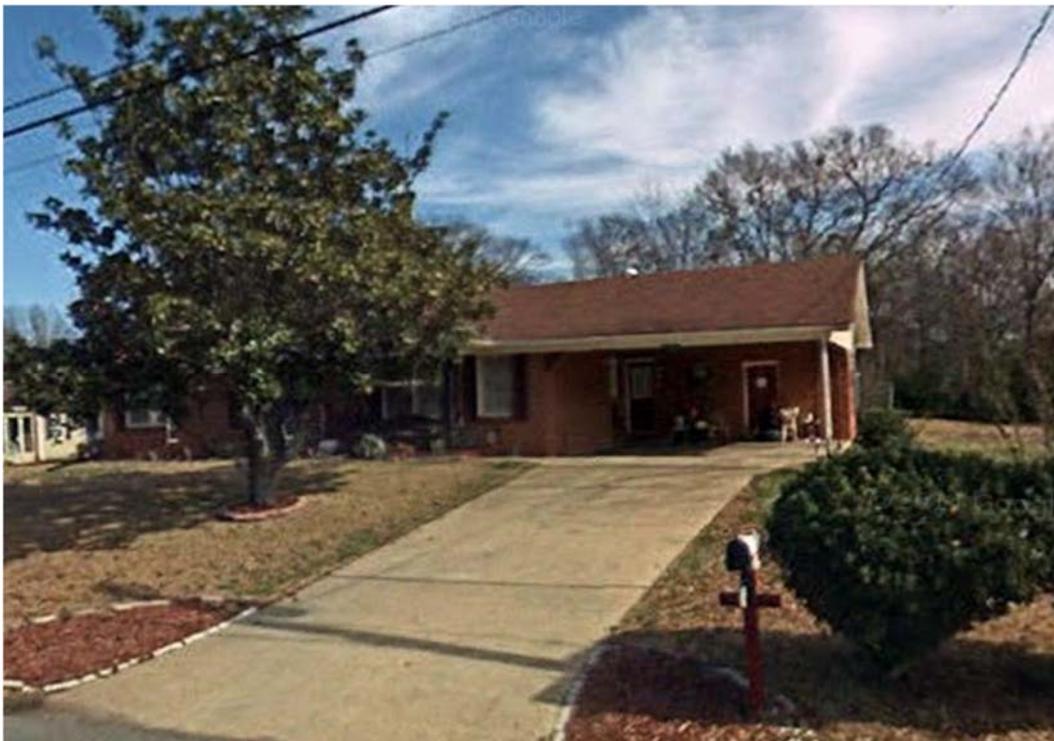
Figure 2. View of Home in February, 2008 from Google Streetview, Looking East. The Carport, Open on Two Sides, is on the Right with a Single Column Support at the Corner.

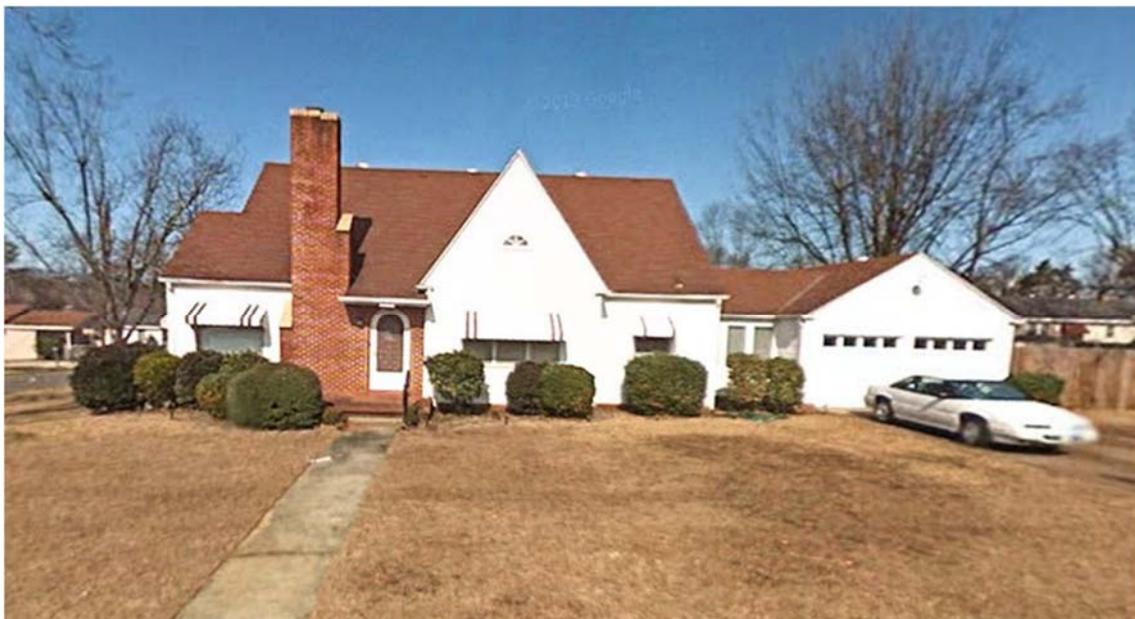
Figure 7. Pre-tornado View of the Case Study #2 Home. Note the Location of the Chimney and the Presence of the Two-car Garage to the Right of the Home, Which is Not Visible After the Tornado.

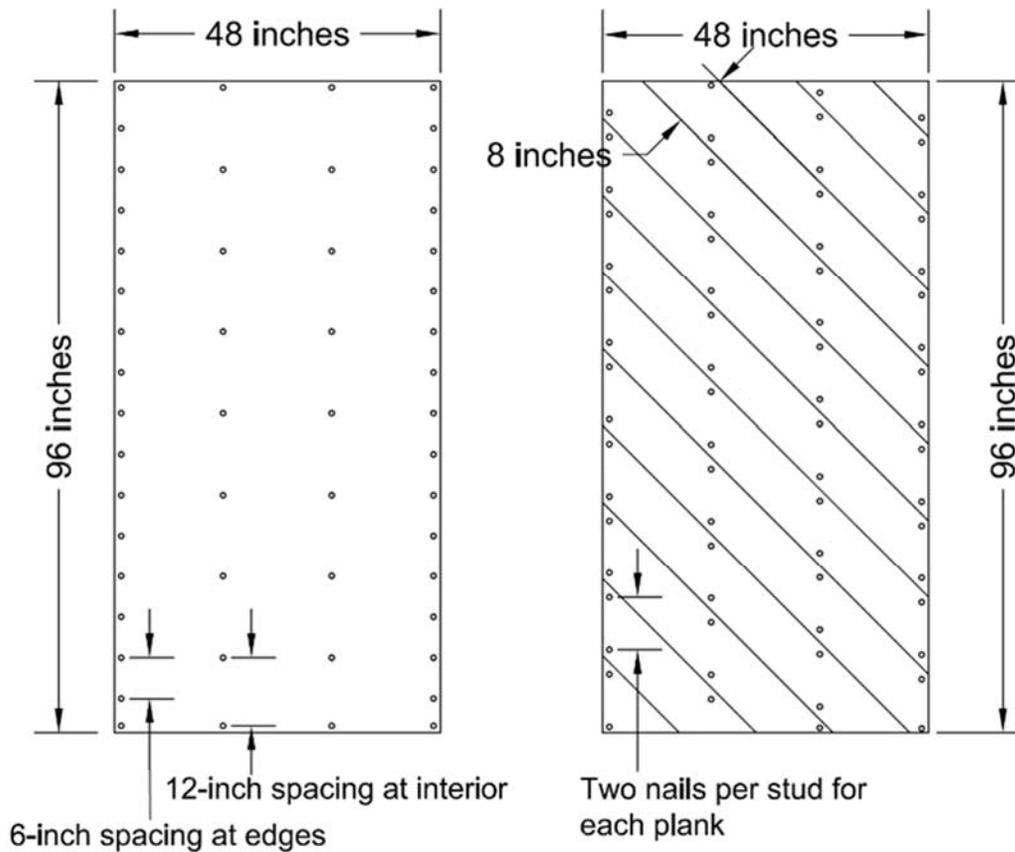
foot by 8 foot sheathing panel is fastened at a 6/12 nailing pattern, meaning the nails are spaced 6 inches on center along the edges of the panel and 12 inches on center in the interior portions of the panel, as shown in Figure 12. This results in a total of 43 nails for panels oriented horizontally, or 52 for panels oriented vertically. For the same area but considering diagonal panels, there would be 60 nails for the horizontal orientation and 69 nails for the vertical (Figure 12), an increase of 40% and 33% respectively. This additional strength likely helped prevent the home from being torn apart by winds

The evidence then indicates that the unique damage to this home is primarily due to structural factors, specifically the robustness of the structural framework, due to bracing of diagonal wood planks and redundant load paths of attic framing the support the roof rafters by the attic framing and gable end wood planks. The robust superstructure was in sharp contrast to the weak, inadequate connections between the ground floor and foundation. Without positive foundation anchorage the entire home could be easily lifted up and

Figure 12. Typical Fastener Schedule for Vertically Oriented Sheathing Panel (left) and Diagonal Planks (right) Assuming Vertical Studs Spaced at 16 inches on Center. Circles Represent Individual Nails.
